A window with different views. The conservation of the ivory windows of Sundari Chowk at the royal palace in Patan, Nepal

■ Regina Anna Friedl, Tatjana Bayerova, Gabriela Krist

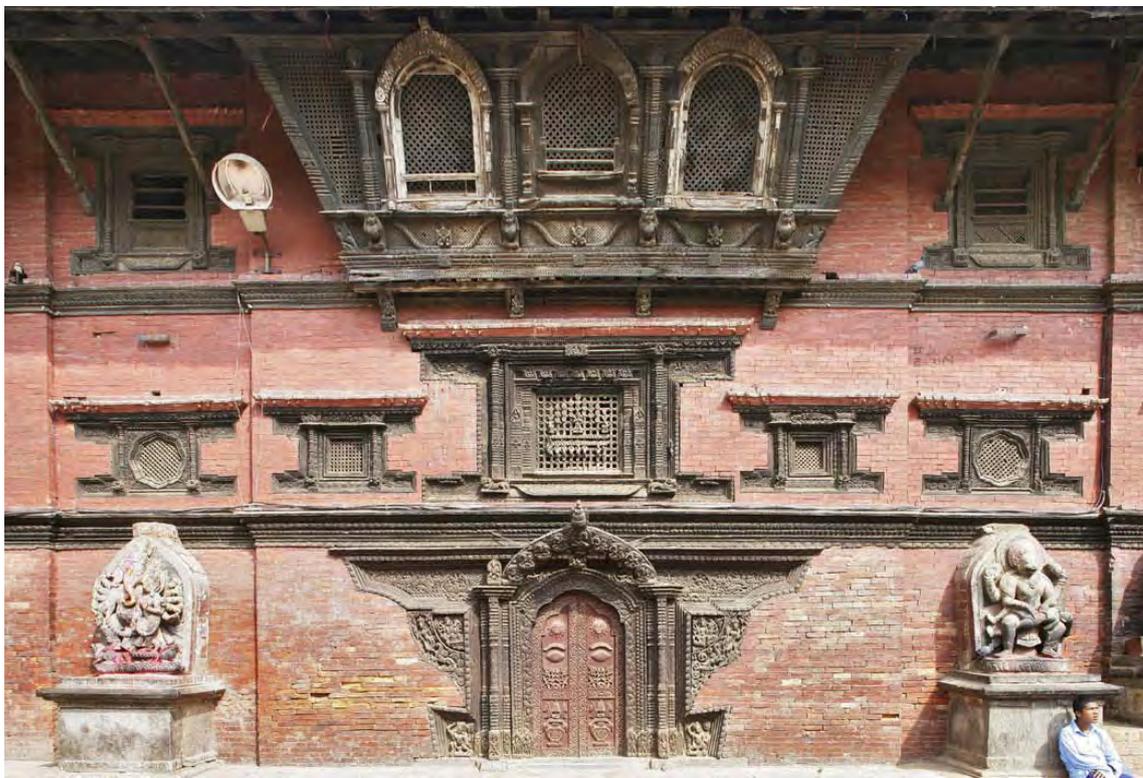
Figure 1 Façade of the Sundari Chowk, facing the Durbar Square.

The ivory window ensemble is located at the royal palace in Patan (figure 1), which is also named Lalitpur - the beautiful city.³ The town, which is the oldest in the Kathmandu Valley, is famous for its beauty and for fine crafts like woodcarving and metal casting. These artworks are visible throughout the city, at the palace and the temples as well as at other buildings around the Durbar Square. The great architecture is a testament to the Malla rulers from the thirteenth to the eighteenth century AD.⁴ The royal palace, which was once the court of the Malla Kings, consists of three different courtyards: the Sundari Chowk, the Mul Chowk and the

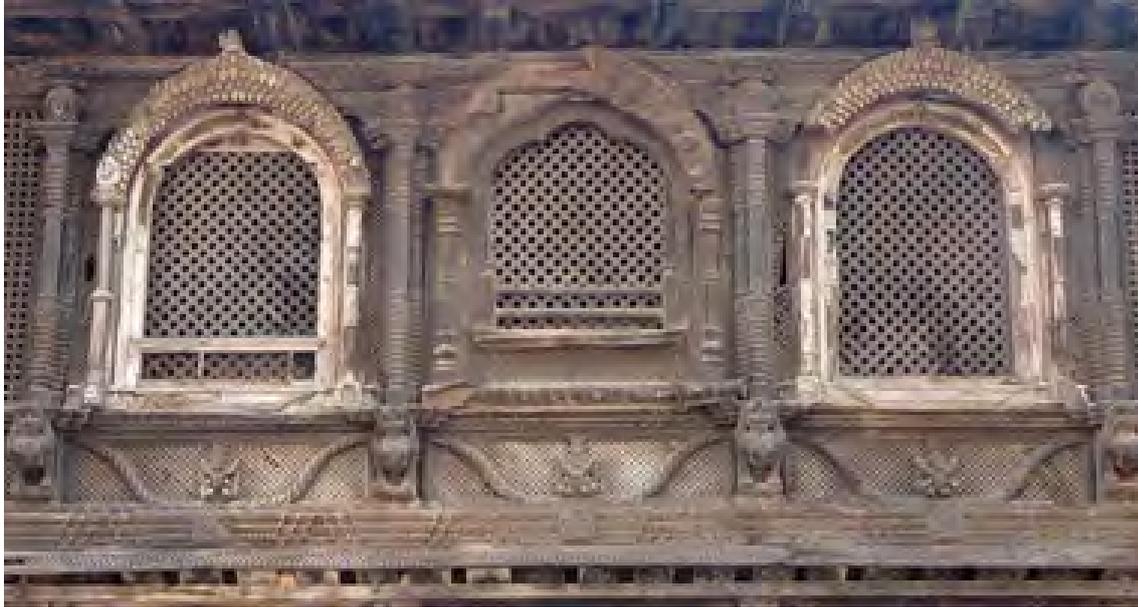
Figure 2 Front elevation of the window ensemble.

The ivory window ensemble is located above the main entrance of the royal palace and overhangs the entrance at an inclined angle from the wall facade (figure 2). The window consists of three openings that are framed by a wooden construction decorated with carved ornaments. The wooden window construction is held together by a plug-in system and is composed of a variety of materials such as ivory, wood,⁷ metal and textile. The ivory from the window ensemble was identified as the being from the Asian elephant (*Elephas maximus indicus*).⁸

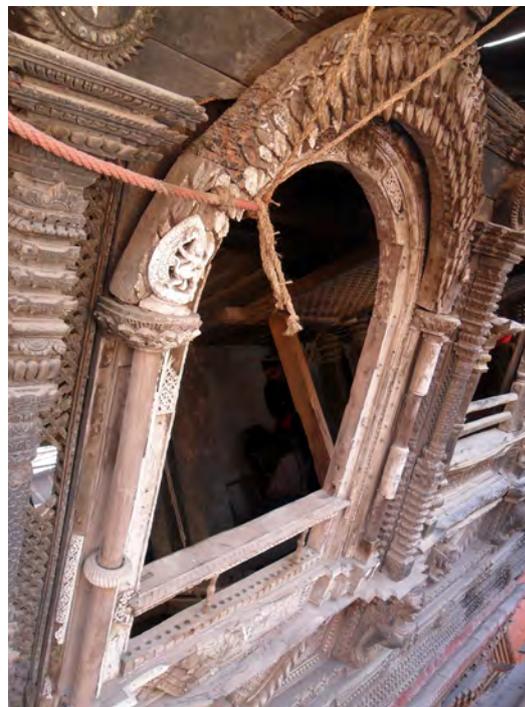
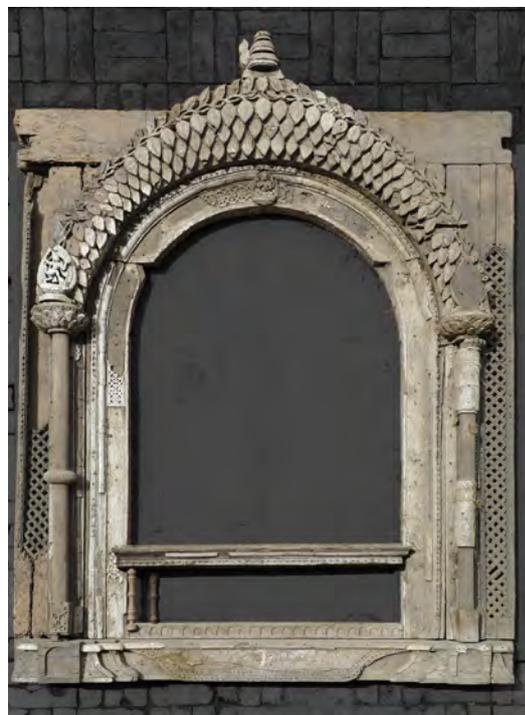
Figures 3,4 Condition of the dismantled ivory window.

The ivory was also in very bad condition. There was only 20% to 30% of the original amount of ivory left and these remnants were badly degraded. Several factors causing decay could be identified: the overall presence of dust and dirt, the white coating, the loss of overall stability due to the fragile and porous surface, leading to a high number of missing parts (figures 3 and 4).

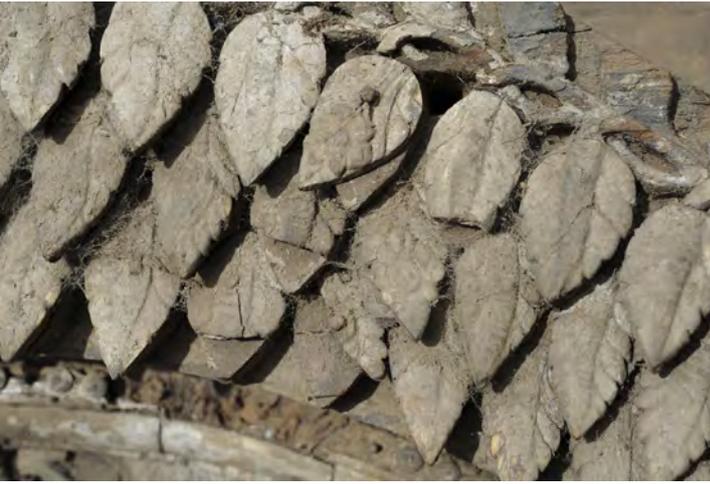
Figure 5 Dust and dirt on the surface of the ivory carvings.

The ivory's surfaces were covered with layers of dust and dirt, which penetrated deep into the ivory matrix and intermediate spaces. The fragile carved ivory pieces were, as already mentioned, covered with a white coating which had probably been applied as a protection against environmental impact. It could also have been applied to cover dust and dirt on the surface of the ivory carvings (figures 5 and 6).

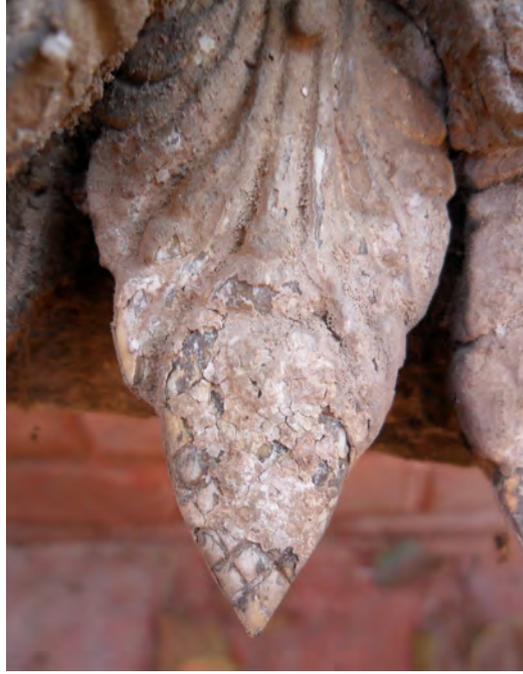
Figure 6 White coating on the ivory carvings.

To identify the white coating analyses were carried out using optical microscopy and scanning electron microscopy with energy dispersive X-rays.²⁶ The examination showed that the coating was composed of four different white paint layers (figure 7). In the bottom paint layer the pigment zinc-white was detected. This finding confirmed the assumption that the white coating is a secondary addition which can be dated, at the earliest, to the second half of the nineteenth century.²⁷ Due to the presence of the coating the fine ivory carvings were no longer visible and, moreover, the coating penetrated very deep into the ivory matrix.

two steps; mechanically with glass fibre brushes and scalpels, followed by a treatment with a laser. The laser cleaning proved to be very gentle to the porous and fragile surface of the ivory: thick layers of dust and dirt as well as the white coating could be removed easily without damaging the surface of the carvings (figures 10 and 11). The consolidation of fragile and degraded ivory parts was carried out with 10% Paraloid B72 in acetone. The consolidant was applied with a soft brush. Broken ivory parts were joined with 30% Paraloid B72 in acetone. All the treated ivory elements were put back into their original place using brass nails. The loose textile wrapping on the pillars was consolidated with 5% Klucel E in ethanol before the ivory carvings were applied. For safety and easier handling, the wooden parts of the ivory windows were pegged together and fixed on a doubled plywood-board (figure 12).

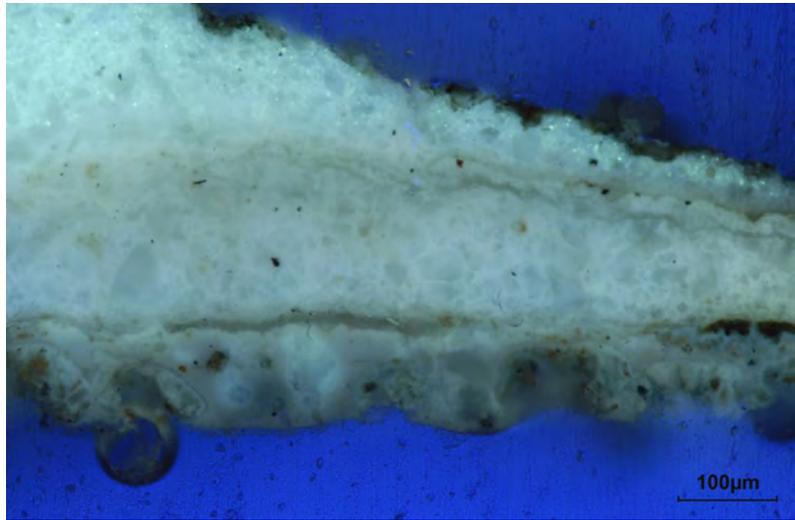
Figure 7 Cross-section of the white coating, reflected-light microscopy and UV light.

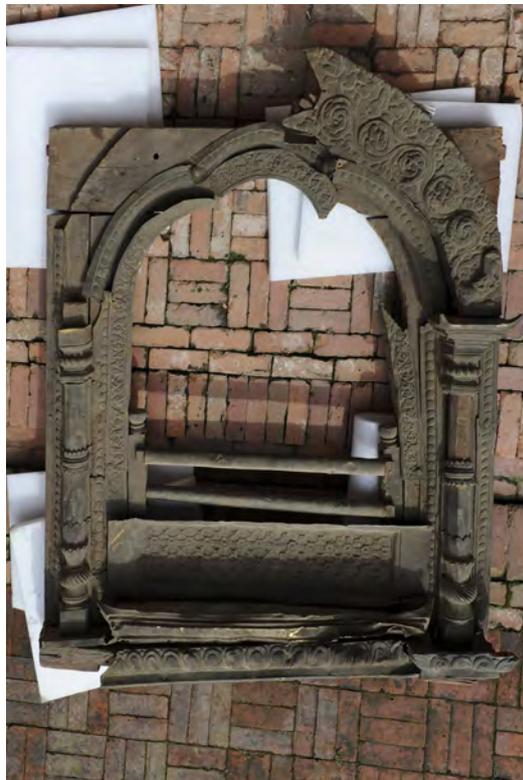
The overall condition of the fire-gilded metal repoussé window was better. About 20% of metal elements were missing and the metal surfaces were covered by hard and dense dirt layers (figure 8). There were also several damages caused by mechanical forces that have led to major deformations in some of the metal parts. In addition some cracks were visible and some metal parts bent out of shape.

Figure 8 Condition of the central metal window.

All metal parts were dismantled from the wooden support for further treatment. Loose dust and dirt was removed with soft brushes. Afterwards, all the metal parts were cleaned with water and mild detergent (Pril). The hard, thick layer of grime was eliminated using a chelating agent which was applied with soft brushes, hard crusts were removed mechanically. After this treatment, the metal elements were rinsed with water to remove any remnants of the chelating agent. Some sensitive surfaces of the gilded repoussé copper were partly cleaned using a low frequency laser.²⁸ The deformed metal parts were reformed into their original shape by a local coppersmith with rubber and skin hammers and placed back onto the wooden frame. The missing parts of the copper repoussé work were reproduced by local craftsmen. To harmonise the appearance of the new metal elements with the preserved original surfaces, new gilding of the overall surface was necessary. An adhesive based on linseed oil (mixture) was applied on the surface and Dukaten Doppelgold gold leaf was used for the gilding. Finally, cotton buds soaked in acetone were gently wiped over the surface to create a uniform appearance of the gilded metal (figure 9).

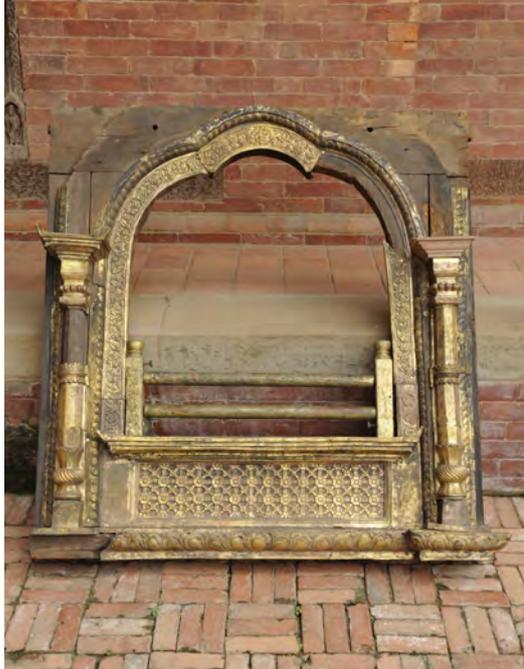
Figure 9 Conserved central metal window, the gilded surface is visible again.

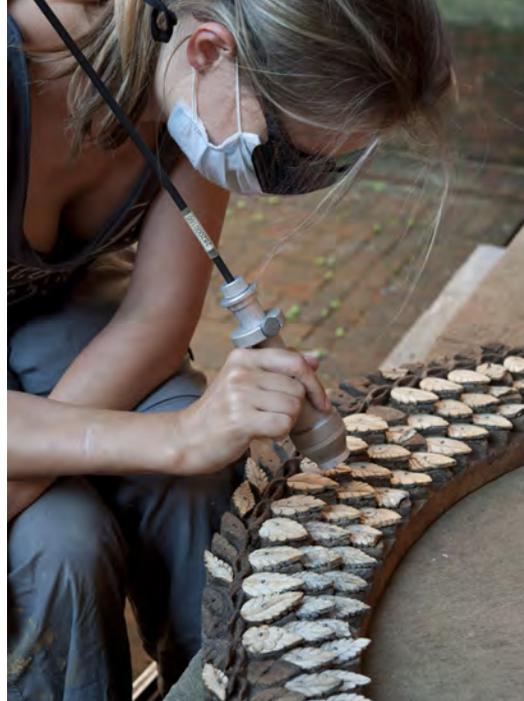
Figure 10 Removal of the white coating with laser.

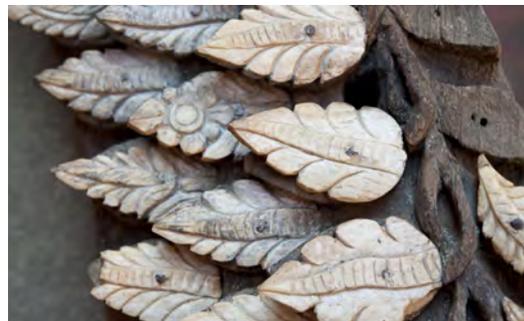
Figure 11 Surface of the carvings after the laser treatment.

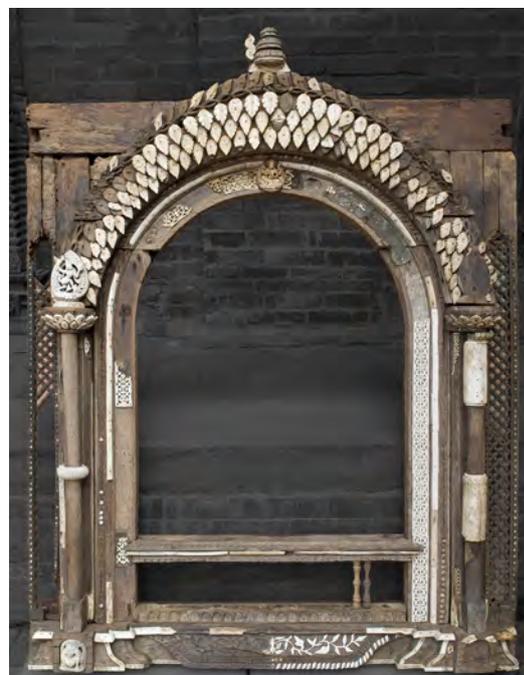
Figure 12 Condition after conservation of the ivory window.

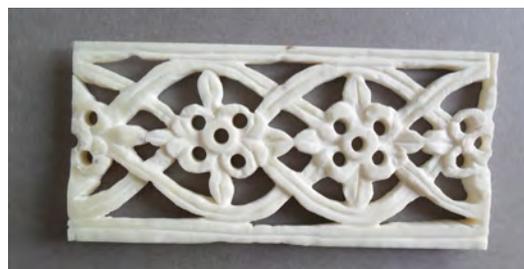
Figure 13 Carved floral pattern, bone.

To use bones for restoration and as reconstruction material they must first be boiled, dried and be free from marrow. After a drying period of about two weeks, fine plates were cut from boiled bone and prepared for carving. Carvings were made using a fine saw, scalpels and other carving tools. As bone is a very hard material, it was not easy to saw and carve it. Nevertheless, the surface of a carved bone plate was very similar to the carved ivory from the windows (figure 13).

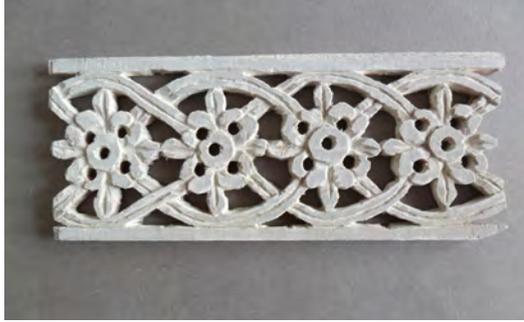
Figure 14 Carved floral pattern, wood.

As there are excellent local craftsmen in Nepal, especially local carvers, the possibility of ivory reconstruction using wood also had to be taken into consideration. From various types of wood, pear wood was selected for testing since it is straight grained and, therefore, suitable for carving.³⁸ A plate of pear wood was carved and painted with white acrylic paint (figure 14),³⁹ but its surface appearance did not match that of ivory. Wood grain was visible through the white paint and disturbed the appearance of the surface.

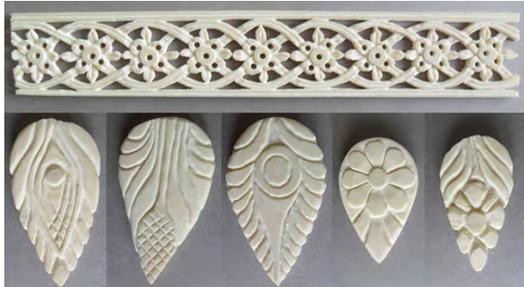
Figure 15 Carved floral pattern and leaf decoration, Elforyn.

Elforyn is available in different shapes and sizes. For the floral patterns Elforyn panels with a size of 3 x 50 x 305 mm and 5 x 50 x 305 mm were used.⁴⁰ Since Elforyn is a soft material suitable for carving, it was easy to saw and to cut it with a scalpel. For the test series, different floral patterns were produced. The appearance of the floral replicas and the workability of Elforyn were good (figure 15), making this material a good choice for using for the reconstruction of the ivory windows.

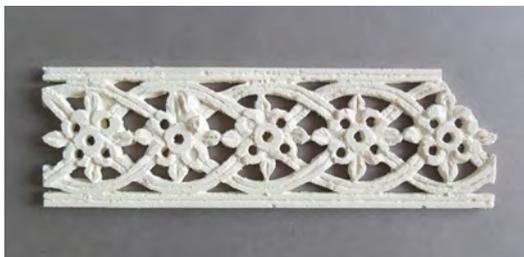
Figure 16 Carved floral pattern, epoxy resin panels.

Mixtures of epoxy resin⁴¹ with different fillers such as bone powder, marble powder, glass microballoons and white pigments were produced and moulded into panels. Despite the presence of small air bubbles in the cured panels (figure 16), they were suitable for the carving of patterns used for the preparation of casting moulds.

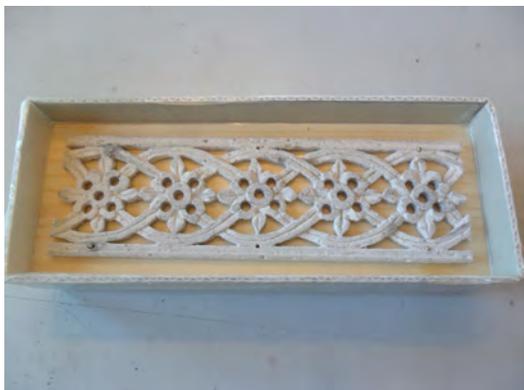
Figure 17 Preparation for the casting mould.

The next step was the preparation of silicone casting moulds from the carved epoxy resin patterns. These were fixed to a wood block with fine nails and a board was fixed around them (figure 17). It was very important that this form board was well sealed, so that the silicone could not leak out. The degassed silicone⁴² was then carefully filled into the form and allowed to dry for about 24 hours. The silicone moulds were ready for making of final replicas in epoxy resin, but this step turned out

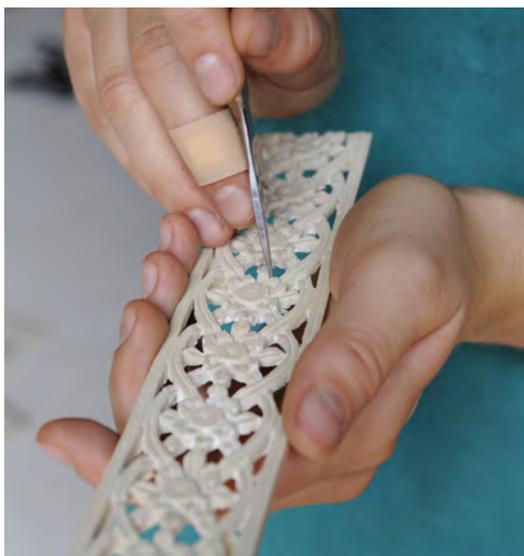
Figure 18 Finished moulded reconstruction.

to be problematic. Due to the presence of fillers like marble powder and bone powder the mould could not be degassed well enough, resulting in a cast with several air bubbles. Therefore, the epoxy resin without any filler, coloured only with white pigment and tinted with a small amount of ochre pigment, was used. The filled moulds had to be degassed for about two hours,⁴³ and the final casts contained hardly any bubbles (figure 18).
